Pro38 BULLETIN

Forward Closure Failures

June 15, 2016

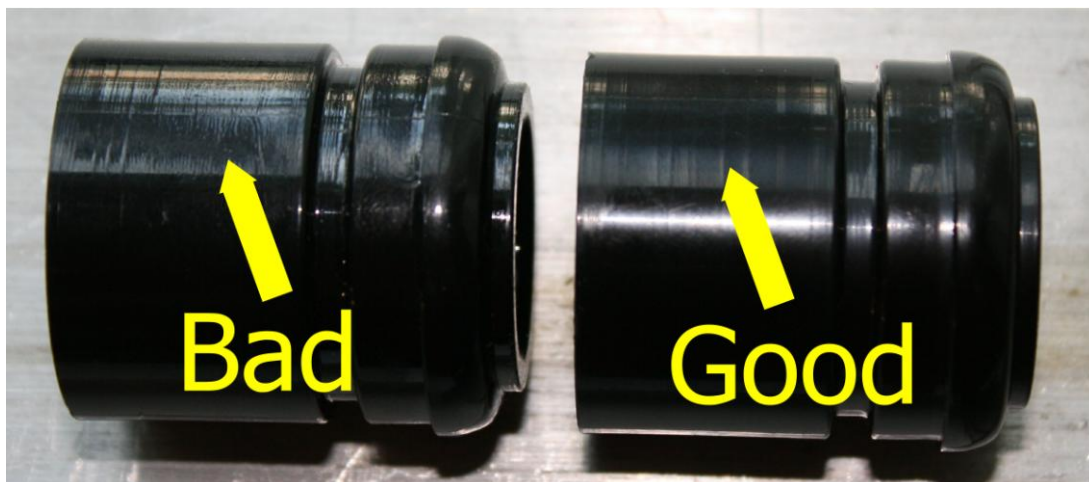
It has been brought to the attention of Cesaroni Technology Inc this past week that there has been a high failure rate on several types of Pro38 motors due to forward closure failures. Upon investigation, the root cause has been identified as a failure from de-bonding between the adhesive/epoxy and the forward closure wall. This adhesive is used to hold the delay grain within forward closure housing, and when a poor bond occurs under pressure this can lead to hot gases tracking through forward closure interface resulting in the failures shown.

Unfortunately the forward closure housing itself does not have a unique serial date to identify the effected motors. In a side by side comparison between bad & good forward closures it is extremely difficult to visually identify the difference. With a very keen eye, under the proper lighting & reflection conditions there is a tiny difference that can be seen. The surface of the bad forward closures will appear to be slightly "wavy."

Additionally, in a side-by-side comparison the bad forward closures will feel more "slippery" to the touch than the good forward closures. However without a side-by-side comparison this will almost be unnoticeable. Again both of

these indicators/checks of bad forward closures involve VERY subtle difference which will be difficult for people to notice without careful observation.

Again not all of these ProX reloads will necessarily have faulty/bad forward closures. However CTI understands the work & effort the HPR community places into their model rockets and how devastating it can be if a failure occurs. As such to rectify this issue CTI will supply all of the listed dealers with replacement forward closures. Any HPR customer who believes they may have a "potentially" affected forward closure can contact their ProX dealer where they purchased the reload. The dealer will provide at no cost the replacement forward closure. Please identify to your dealer in advance the exact reload model number to receive the appropriate forward closure/delay module. Please dispose of the faulty forward closure/delay module as outline in the instructions and SDS.
